SWIMMING POOL PATIO/RETAINING WALL EVALUATION

THE HOMES AT SWAN POND

WALPOLE, MASSACHUSETTS

**RE: Swimming Pool Wall/Patio Evaluation
The Homes at Swan Pond
Walpole, Massachusetts**

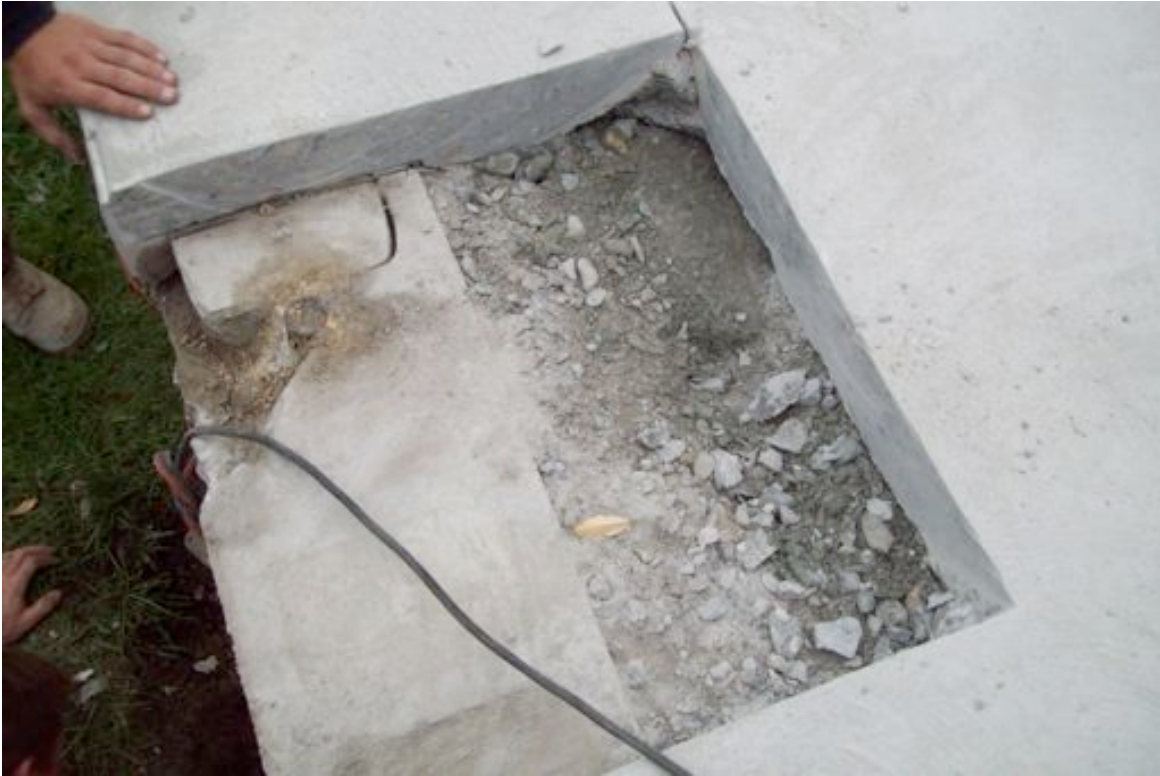
Based on the exposed side of the patio/wall near the pool building basement, we have always assumed we would find a concrete block wall built on a poured in place concrete foundation (see photo). However, test cuts revealed differing construction in each of the 2 new areas that were cut open and examined. A test cut at the side of the pool, in the corner where it meets the newer segmental block wall, revealed a 12” concrete block wall on a concrete block foundation (see photo). Next, a portion of the patio was removed near the top of the access ramp, at which we discovered a poured concrete structure all the way up to the underside of the patio (see photo). So in three areas that we have investigated or examined we found; 1) a concrete block wall on a poured concrete foundation; 2) a concrete block wall extending completely below grade (unknown if there is also a poured concrete foundation); and 3) a poured concrete wall all the way to the underside of the patio.

TEST CUT #1 REVEALED A BLOCK WALL

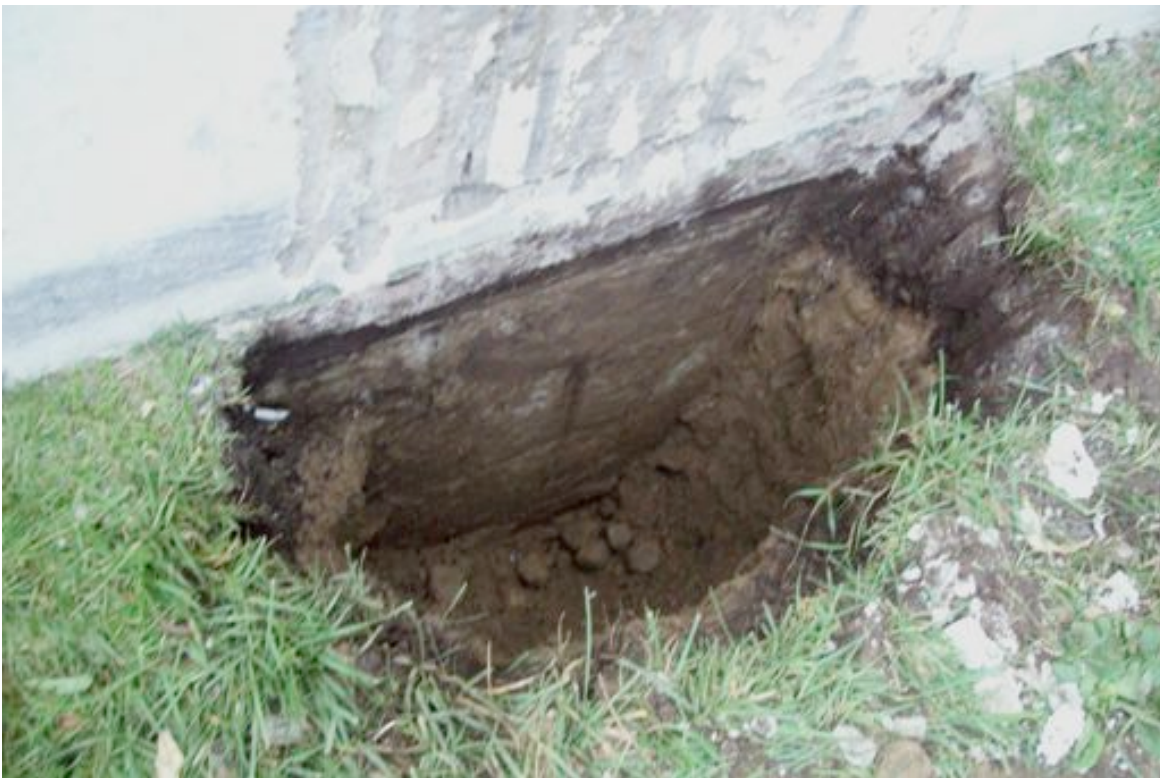
THE FOUNDATION BELOW THE WALL AT TEST CUT #1 IS OF CONCRETE BLOCK

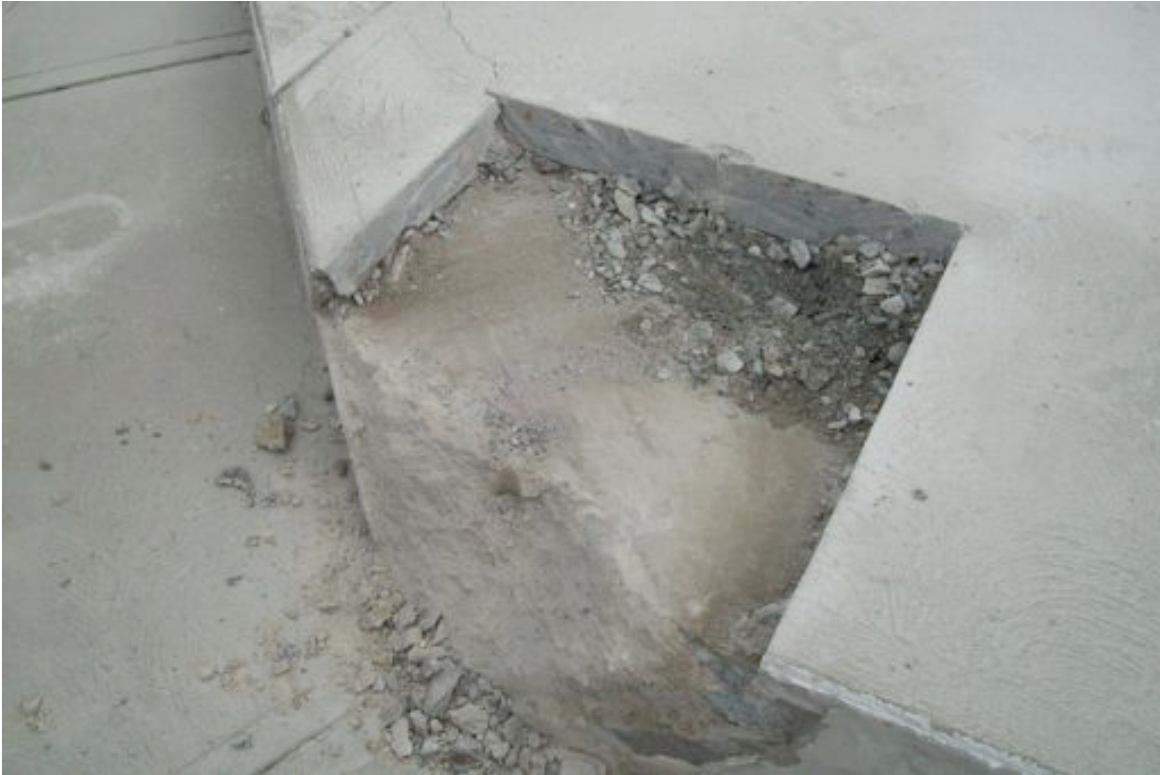
TEST CUT #2 NEAR THE ACCESS RAMP, REVEALED A Poured CONCRETE WALL

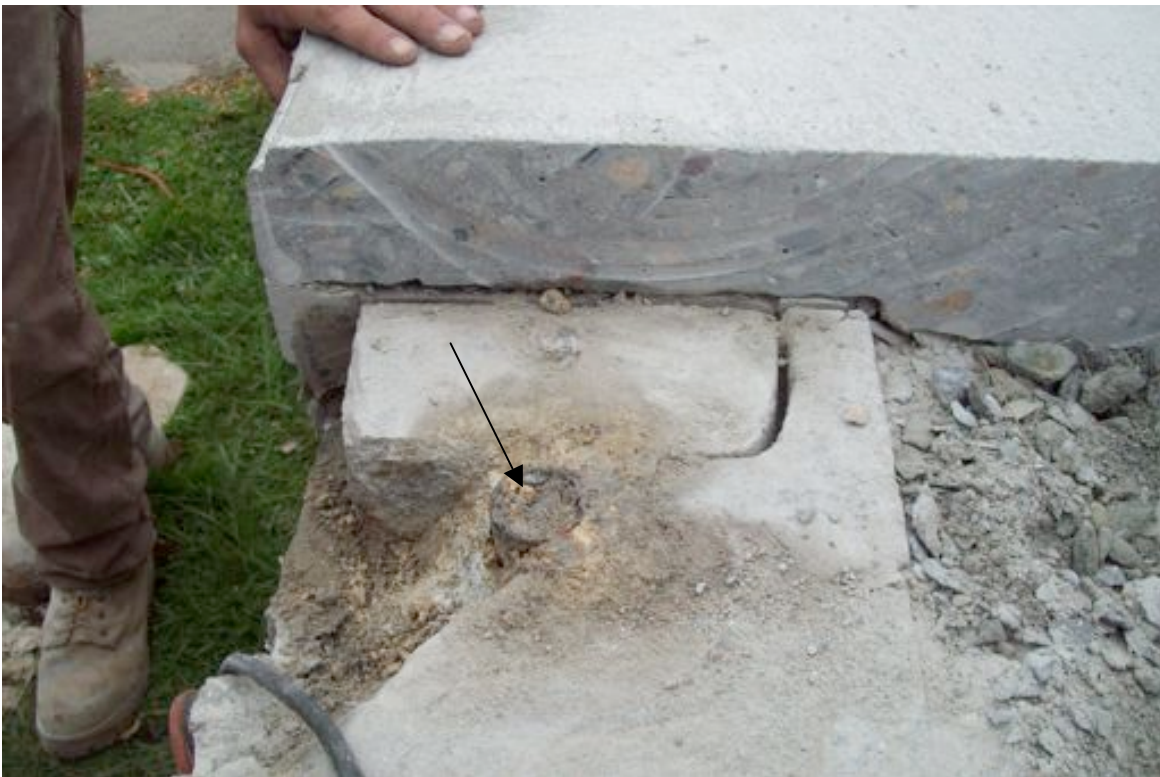
Along with finding three different wall/foundation scenarios, we determined that compaction of the substrate when the patio was replaced was poor. We also believe that the majority of water damage was occurring as a result of water getting below the slab and on top of the wall through the fence post sleeves (see photo). The discovery of three different wall assemblies has complicated the process of replacing the wall, but may have pointed us toward a less disruptive, and less costly project, that may prove to be a fairly long-term solution. A poured concrete wall should not be placed on top of a block foundation, nor should a segmental block wall.

THE MAJOR DAMAGE TO THE PARGE COAT WAS CAUSED BY WATER PENETRATION THROUGH THE FENCE POST SLEEVES

Once the new cap is finished, we would advise removing the original cracking, loose parge coat from the face of the block wall. After all loose materials are removed, the wall should be thoroughly powerwashed to a clean condition, prior to applying a new parge coat. It is possible that mechanical cleaning will be required prior to re-application of a parge coat.

Finally, we are advising that the swimming pool fence not be re-installed through the wall cap. Along the access ramp, connecting to the cap may be un-avoidable. However, rather than putting sleeves through the cap, we would advise utilizing mechanical fasteners (expansion sleeve anchors) to attach a galvanized post with a 4" x 4" flat base. At the side of the pool (facing the Clubhouse), we would advise installing a new 8' tall fence through the lower swimming pool slab (in front of the new wall cap). This will eliminate the need to penetrate the new cap, and will effectively hide the face of the wall, in case the parge coat begins to spall off again in the future.

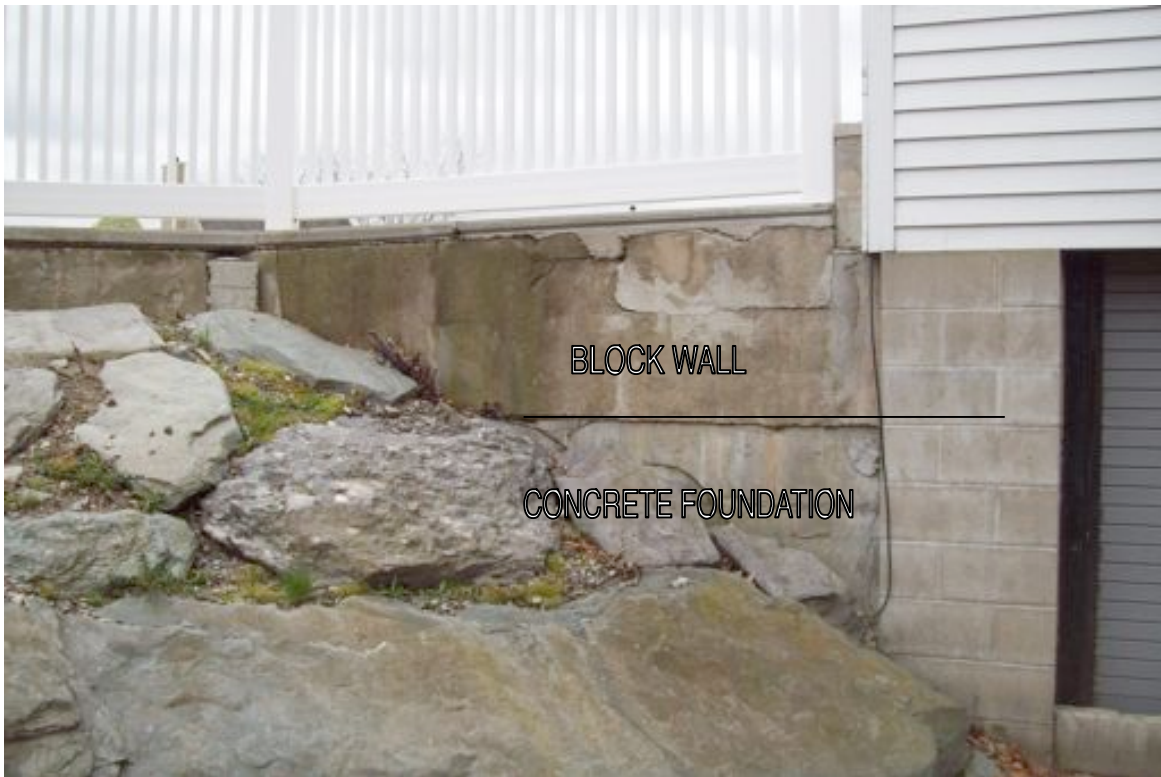
NEAR THE POOL BUILDING, THERE IS A BLOCK WALL ON A Poured CONCRETE FOUNDATION

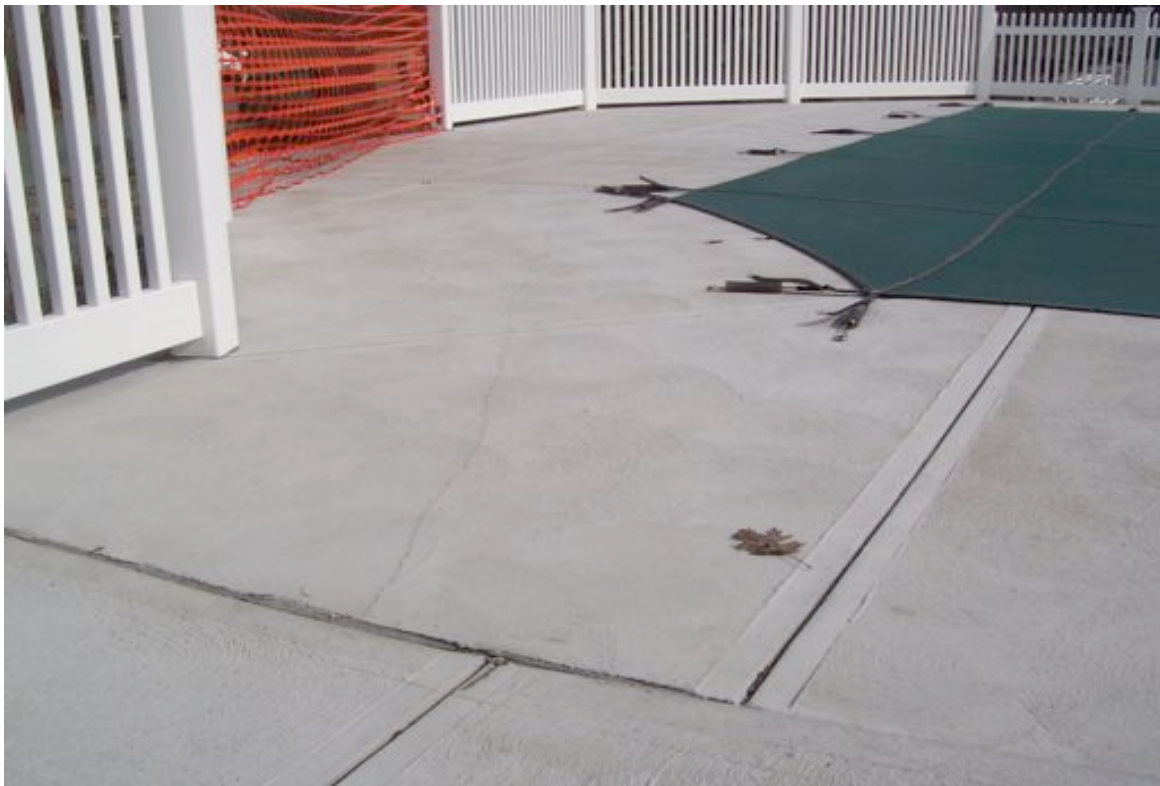
PATIO CRACKING OPPOSITE THE ACCESS RAMP EXTENDS BEYOND 4' FROM THE EDGE

The first step in this process will be to saw cut and remove the concrete patio to a point just behind the pool cover tie-down points. This will remove approximately 90% of the patio slab cracking. In the corner opposite the access ramp, additional portions of the patio will have to be removed if the intent is to remove ALL patio slab cracks. Once the patio slab has been removed, substantial re-compaction of the substrate will be needed. We expect the Contractor will have to truck in some additional materials to fill the voids. However, the amount of additional fill that will need to be brought in cannot be determined until more of the substrate is revealed.
